EURO CONSTRUCTION, INC.

**Re: Bluff Villas
Sea Pines Plantation
Hilton Head Island, SC 29928**

Pursuant to your request, EURO Construction, Inc. in conjunction with Advance Roofing Services have performed a visual survey of the above referenced property on October 27, 2009. The purpose of the survey was to determine the condition of roof covering on buildings #2, #3 & #5 and to determine overall condition of other exterior elements. A summary of relevant observations made during the survey is provided below.

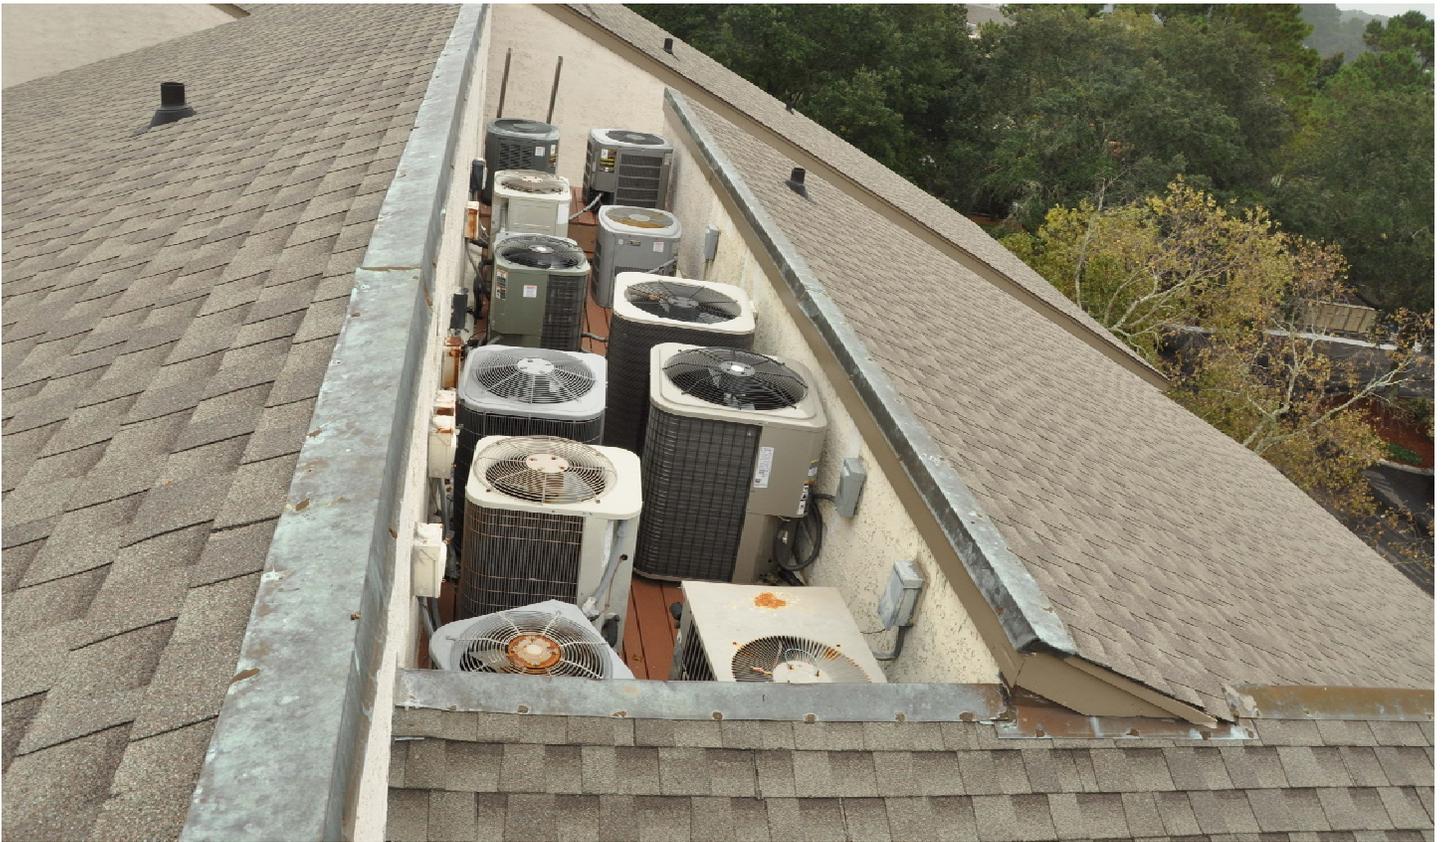
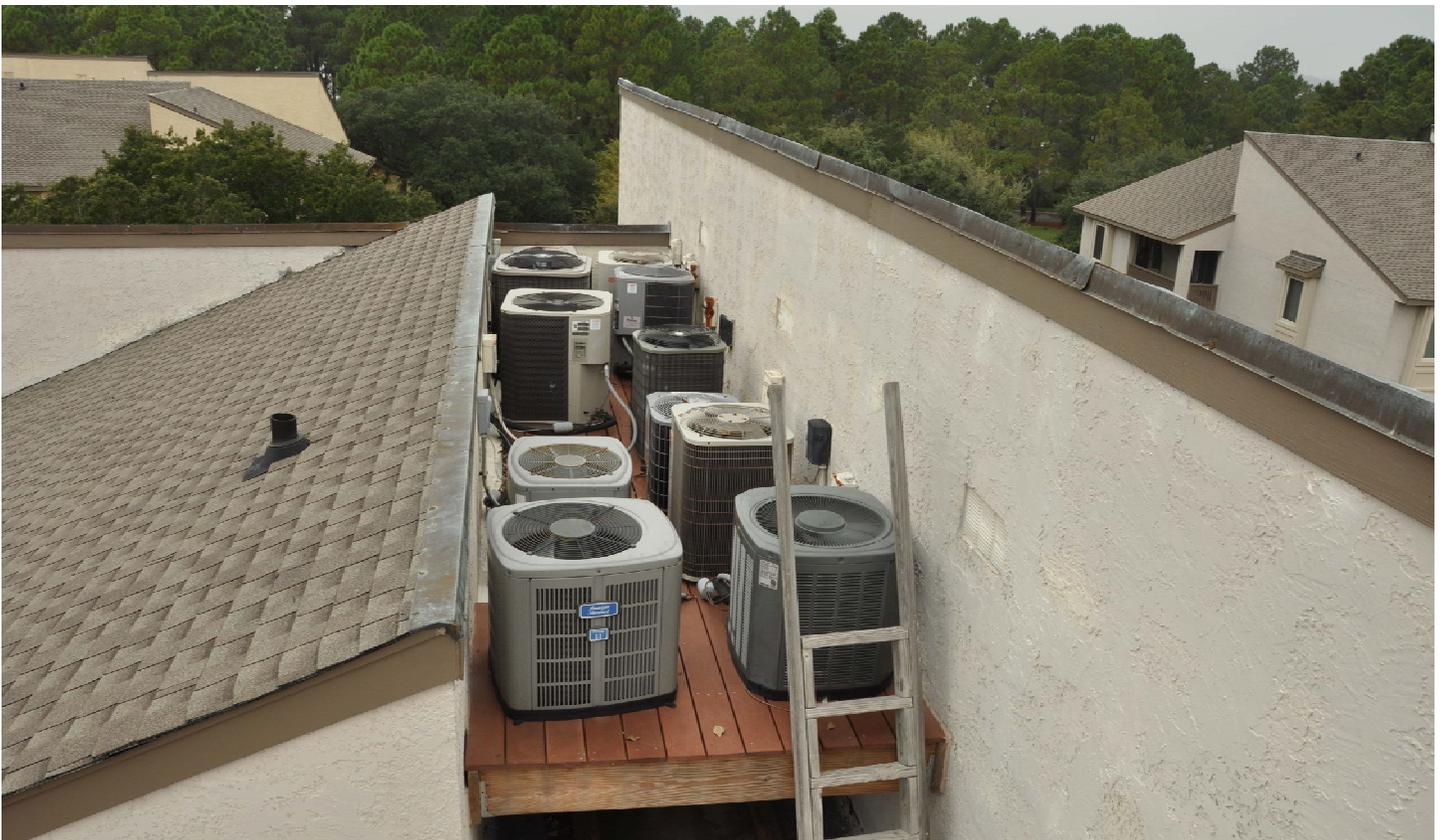
1. A/C compressors placed on wood platform below main roof (pictures 001 and 002) are to close to each other and/or enclosure walls. Manufacturer's required clearance is minimum 12 inches on all four sides to ensure proper ventilation and warranty coverage. Some metal disconnect boxes are rusty.

P001. Bluff Villas. Building #5

P002. Bluff Villas. Building #5

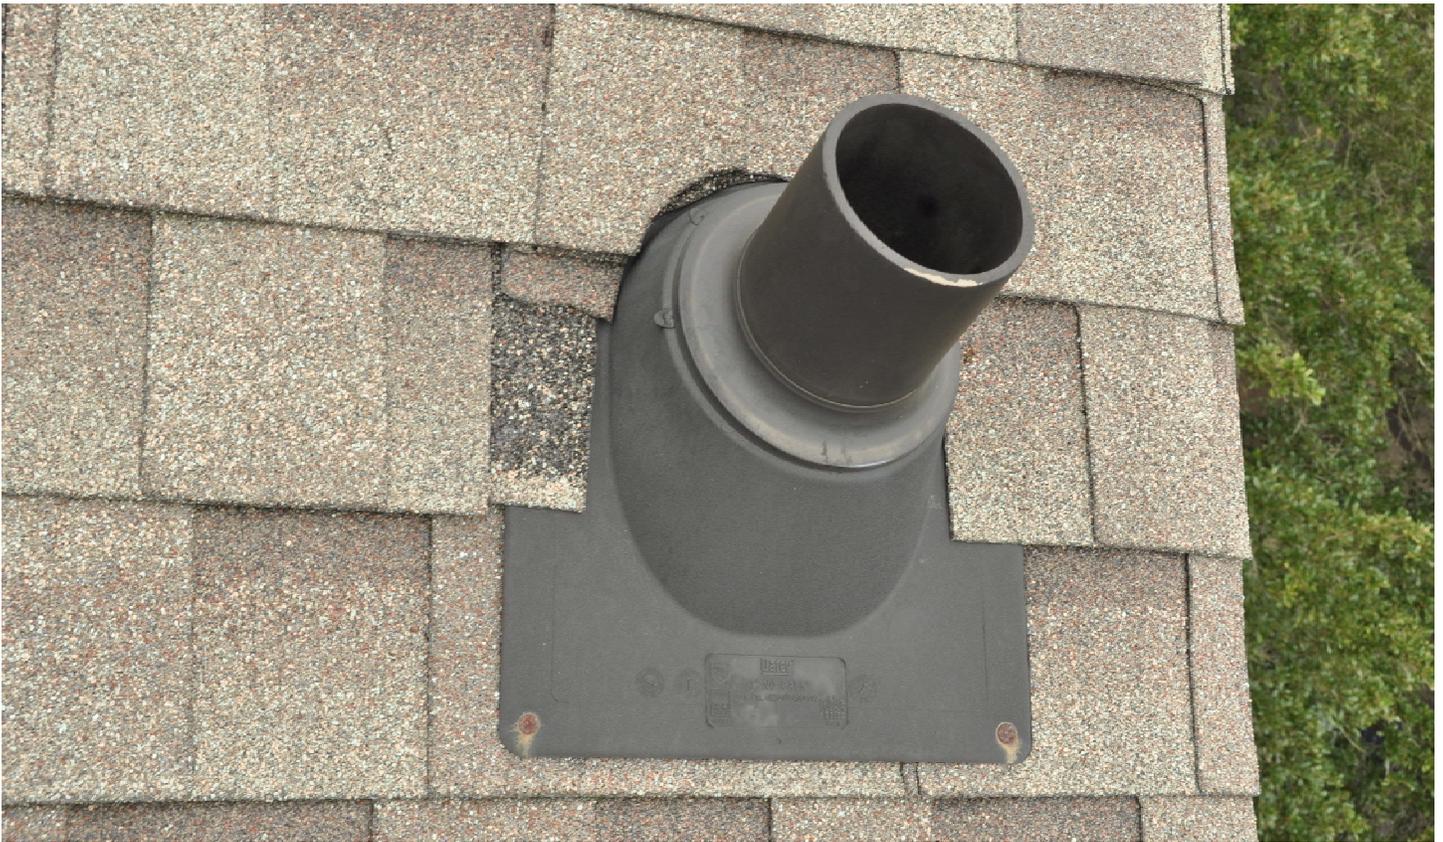
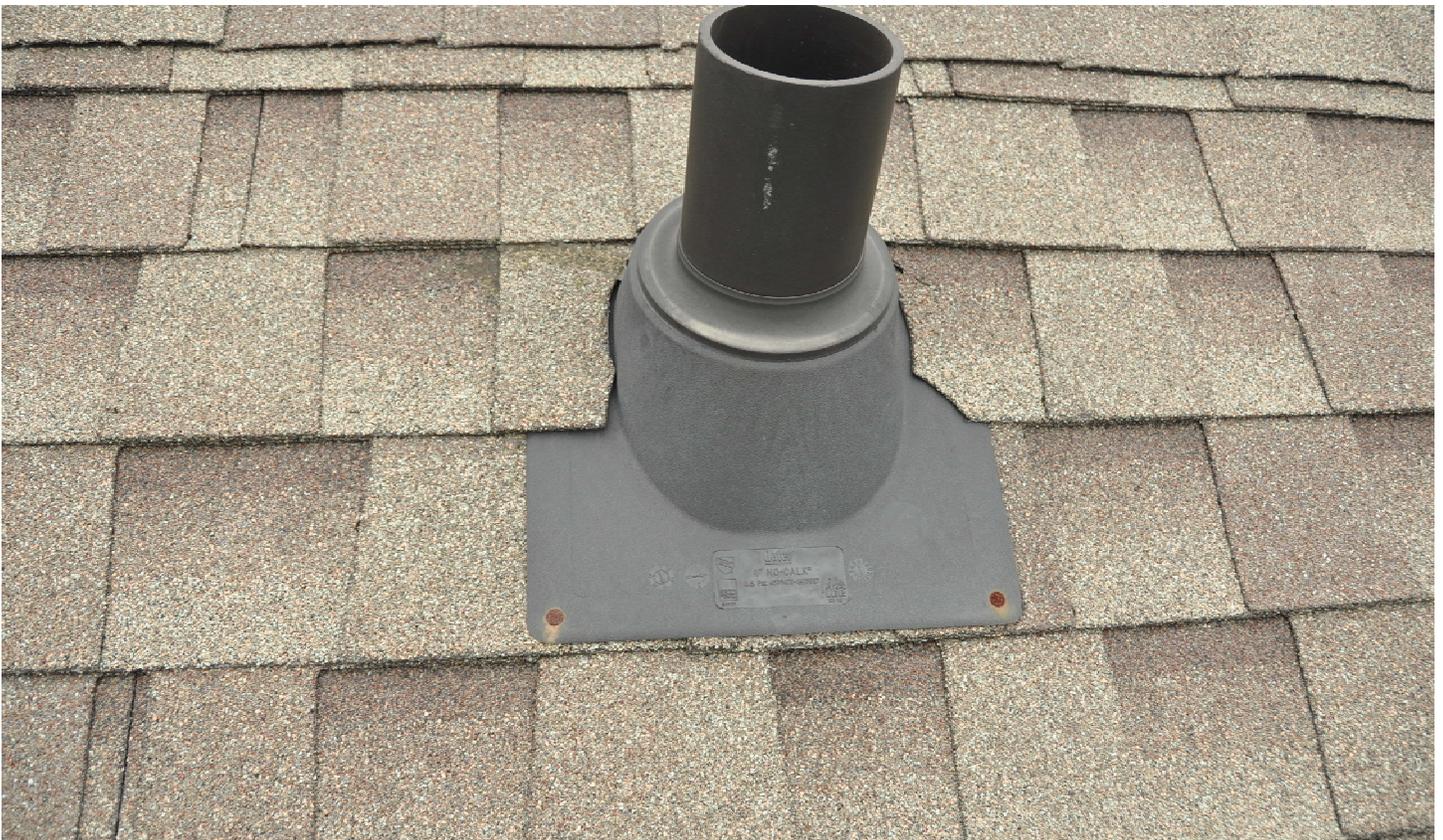
2. Many pipe boots and the rear side of the roofs have exposed rusting nails (Pictures 003 & 004). Any exposed fasteners on roof covering must be sealed with roof tar or other approved sealer.

P003. Bluff Villas. Building #5

P004. Bluff Villas. Building #5

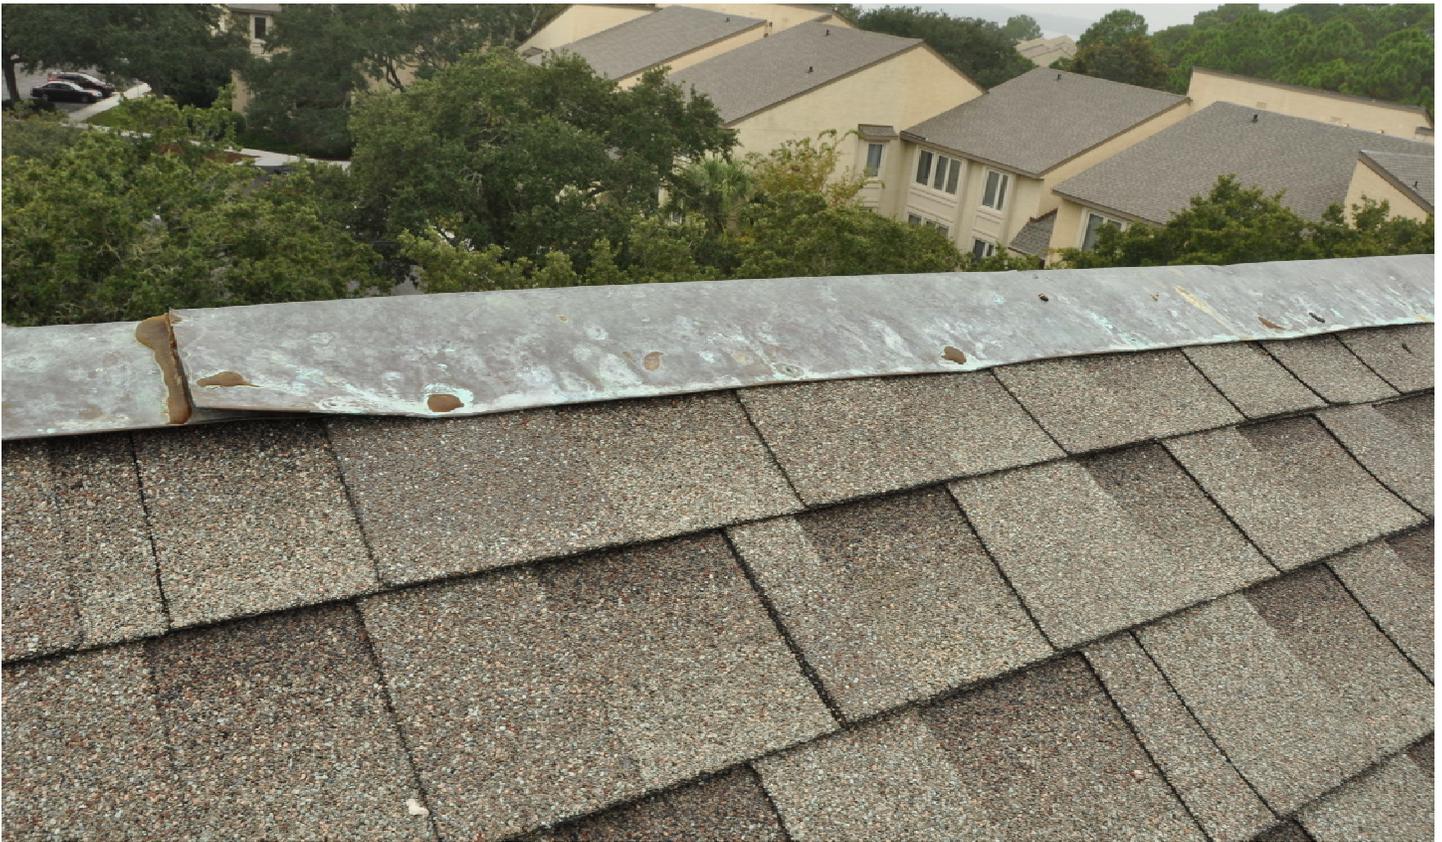
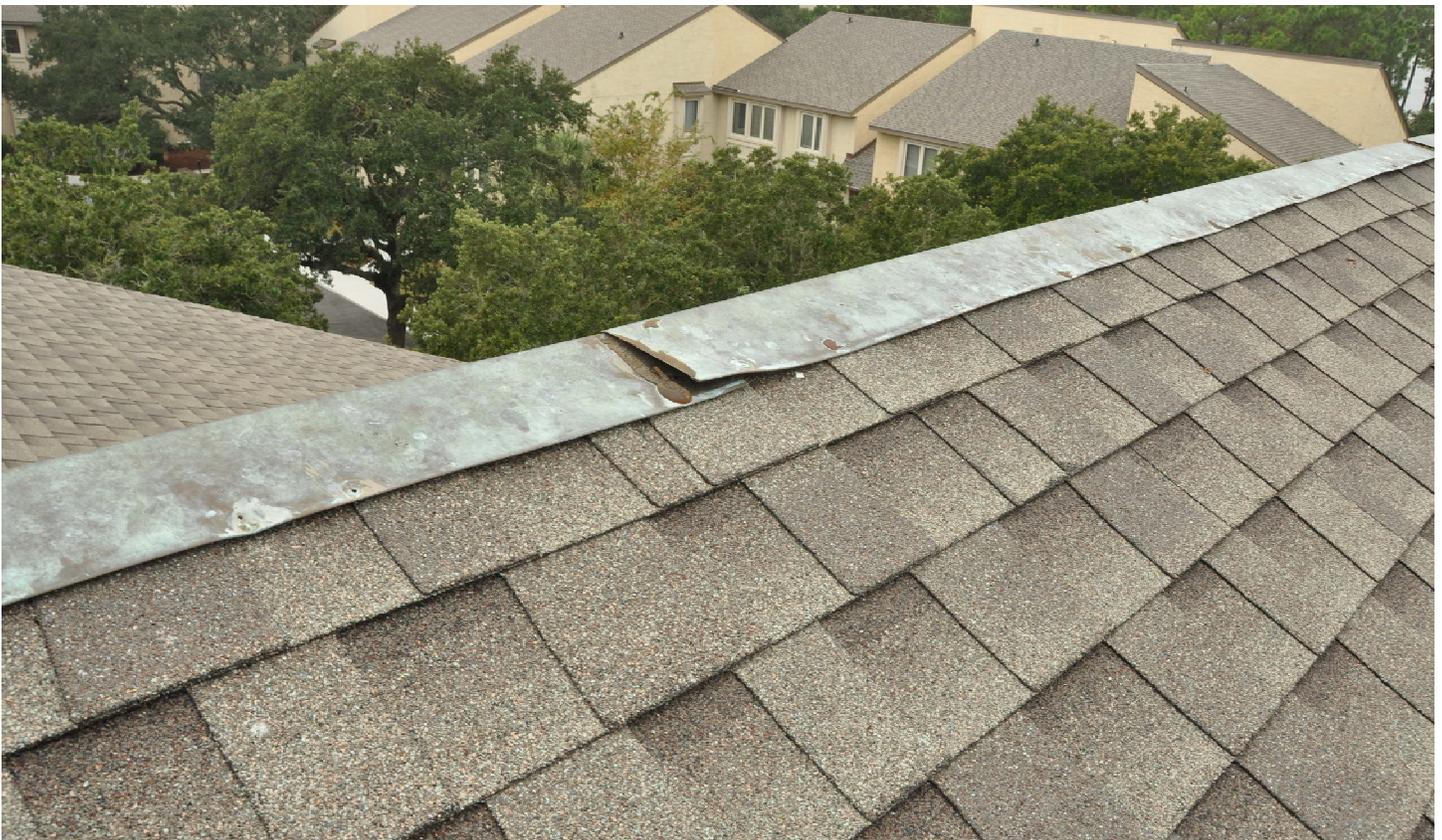
3. Aluminum roof top flashing is too narrow for current roof slope (Pictures 005 & 006). Wind-driven rain may penetrate behind flashing into wall structure below. Apparently, these flashings were reused at the time of last roof replacement. Many unsealed holes exist along the entire perimeter. Joint seal failure is evident in many joints allowing wind-driven rain to penetrate behind flashing. Overall roof shingles condition is good. Many shingles are little brittle, which is normal, keeping in mind current age of the roofs. There is still enough flexibility left in shingles to continue serving as roof covering. We were not able to find any significant granular loss on shingle surface. In our opinion, estimated remaining life for most general areas of buildings #2, #3 & #5 should be eight to ten years (with recommended necessary repairs). The biggest issues with roofing are with improper flashing installations

P005. Bluff Villas. Building #5

P006. Bluff Villas. Building #5

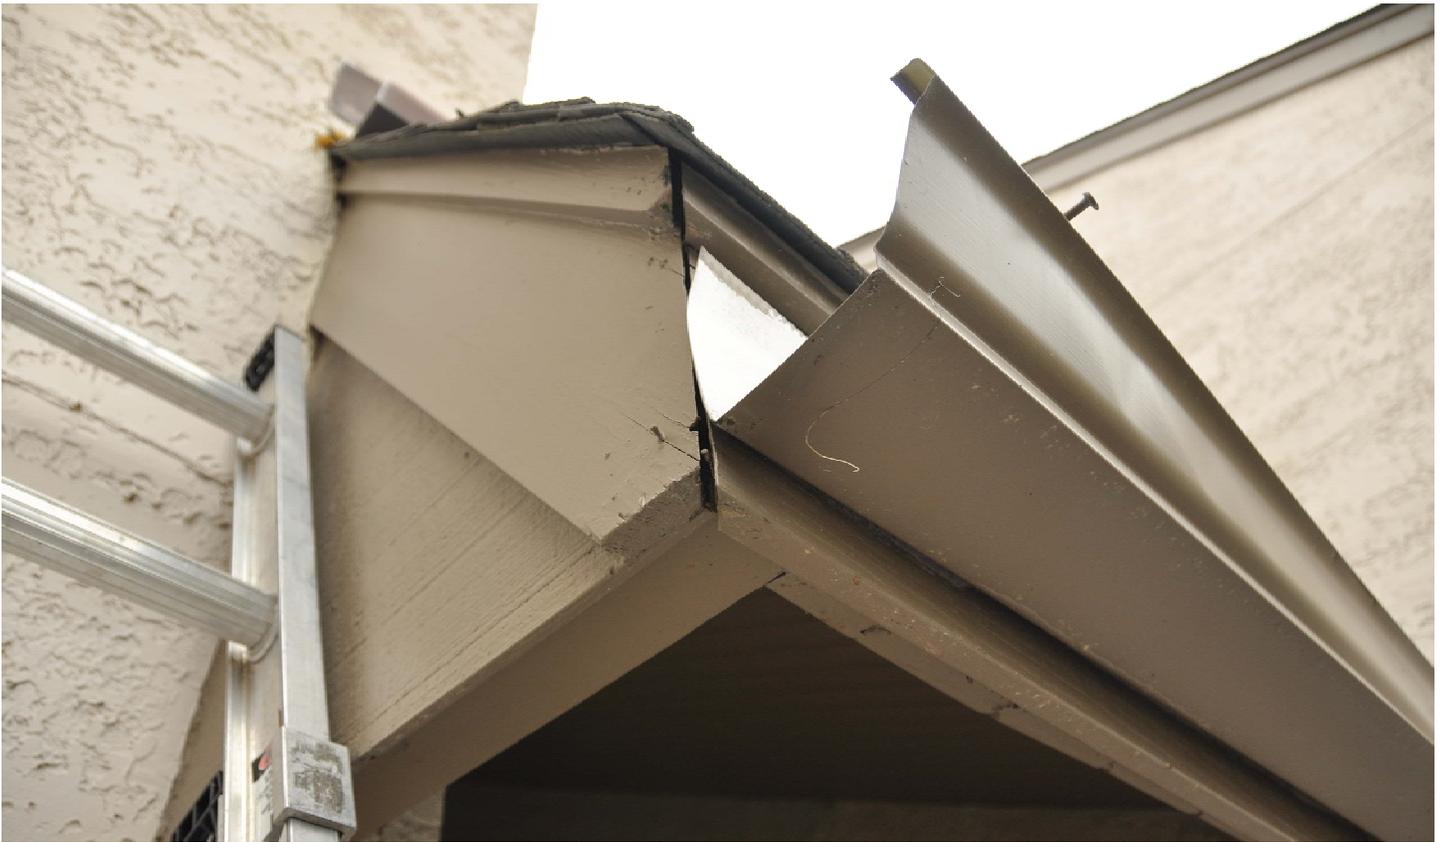
4. The ends of many fascia boards appear to be partially compromised due to long-term weathering and water intrusion at the joints (Pictures 007, 010, 011 & 012). It appears that most fascia boards are nearing the end of usefull life. Moderate to severe wood aging and warping is evident in many areas. Dimensional changes and aging due to long-term exposure to the weather have resulted in numerous splits along wood grain, creating possible rain water penetration behind fascia trim (Picture 012).

6. At the time of visual survey, we were not able to determine the cause for sagging roof condition in entry roofs (Pictures 007, 008, 009, 019 & 020). Destructive testing would be required in order to determine what is causing these conditions. There is no sealant application behind gutter, though fascia trim boards on the end of entry roofs appears to be in fairly good condition. It is possible, that improper flashing installation at the end of entry roofs, resulting in water penetration behind shingles and wood deterioration in roof plywood and, possibly, rafters. In oerder to determine what’s causing issues with entry roofs, some ceiling boards need to be removed.

P007. Bluff Villas. Building #5 Right side entry.

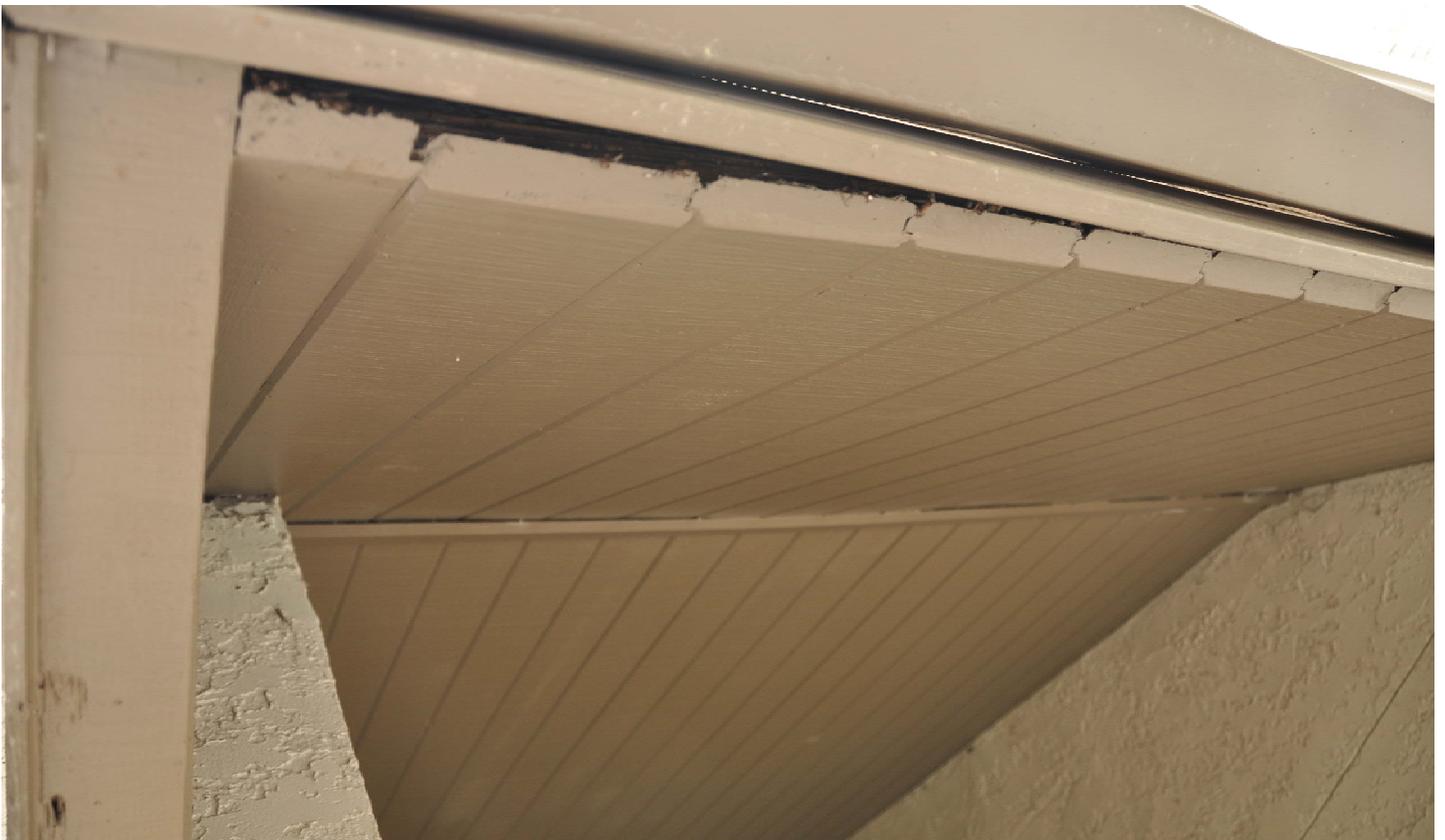
P008. Bluff Villas. Building #5 Right side entry.

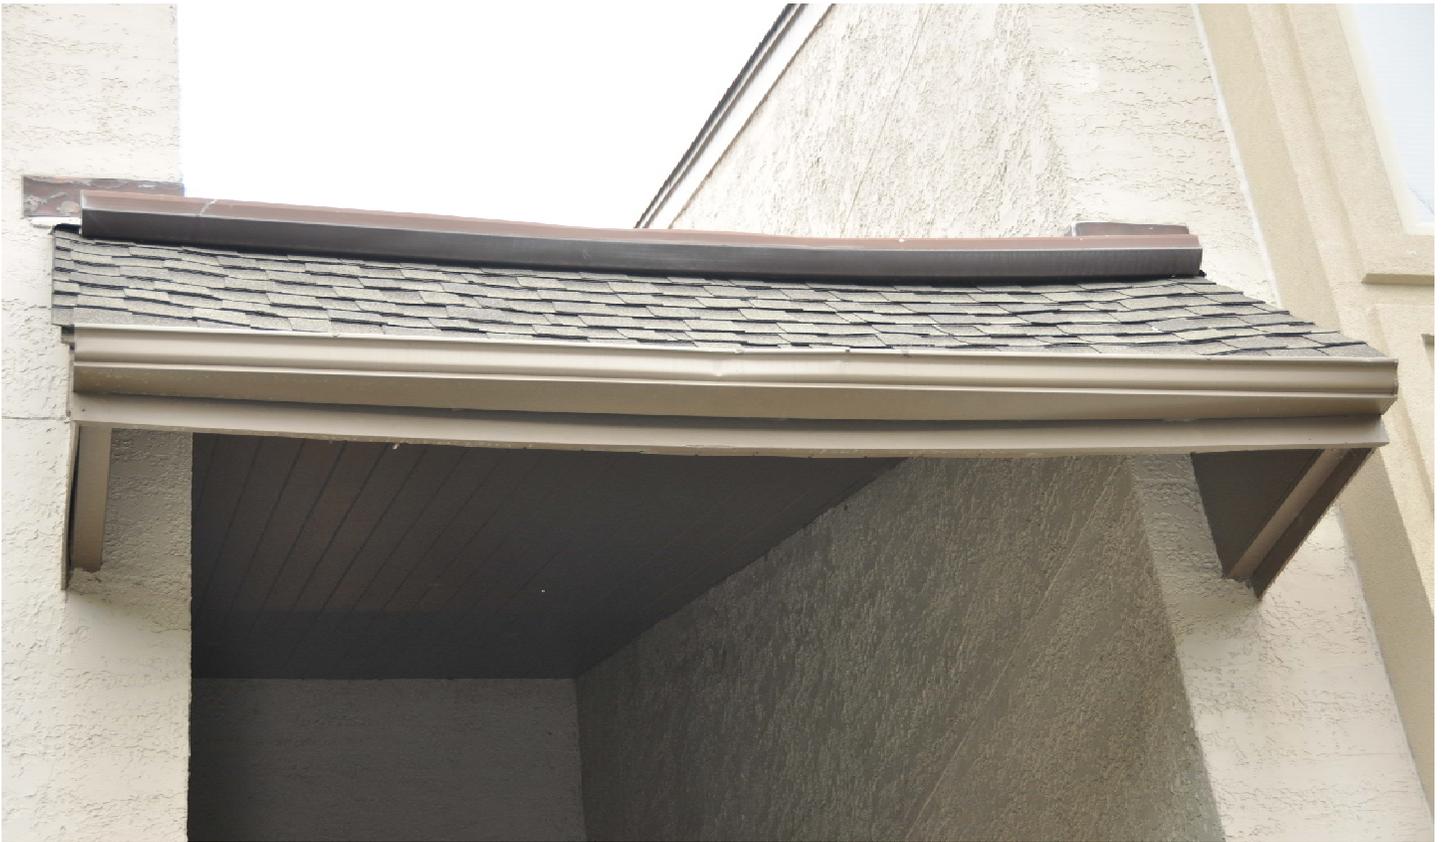
P009. Bluff Villas. Building #5 Left side entry roof

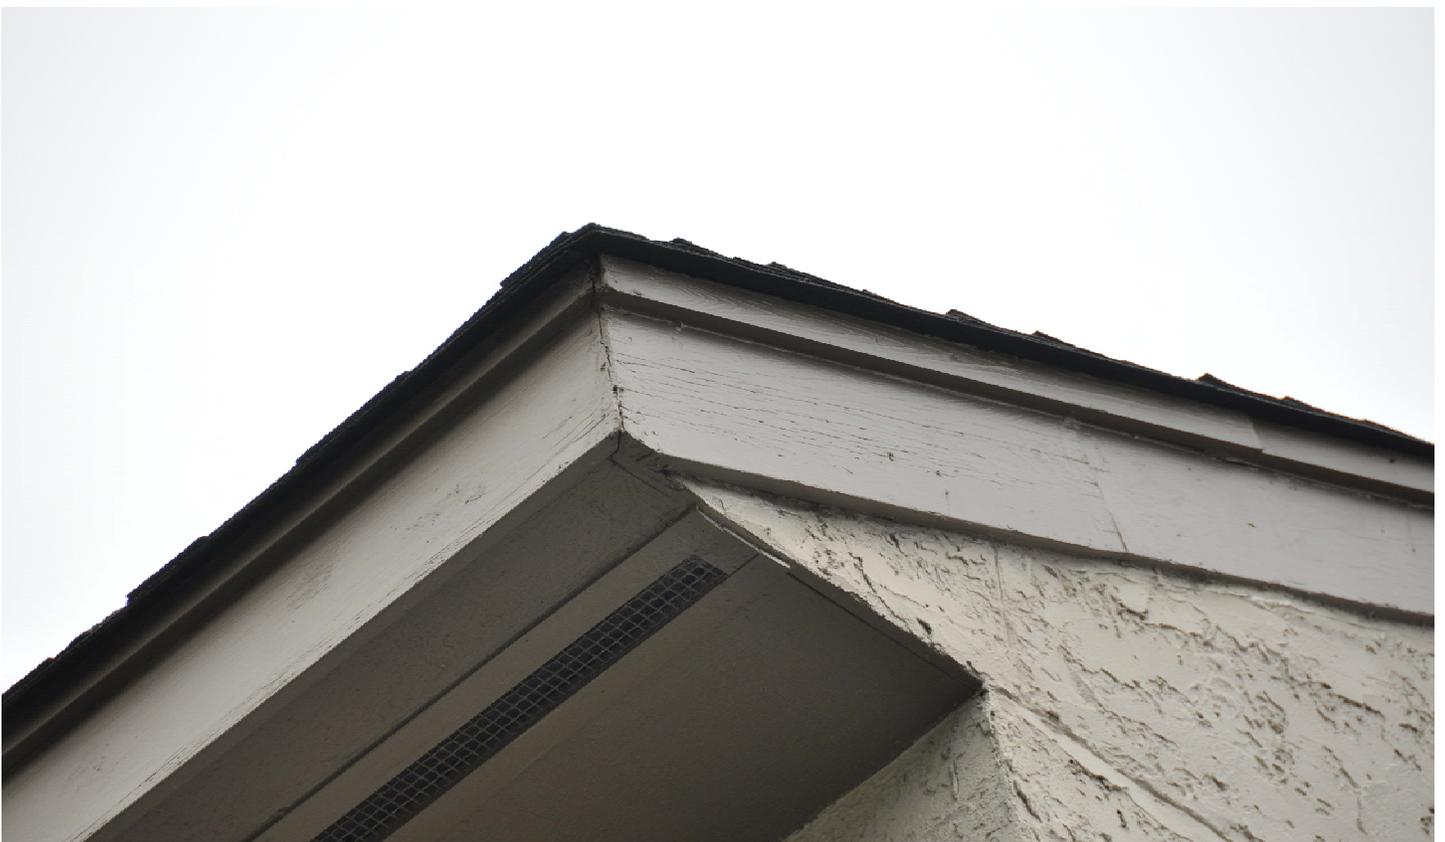
P010. Bluff Villas. Building #5. Corner of fascia trim board

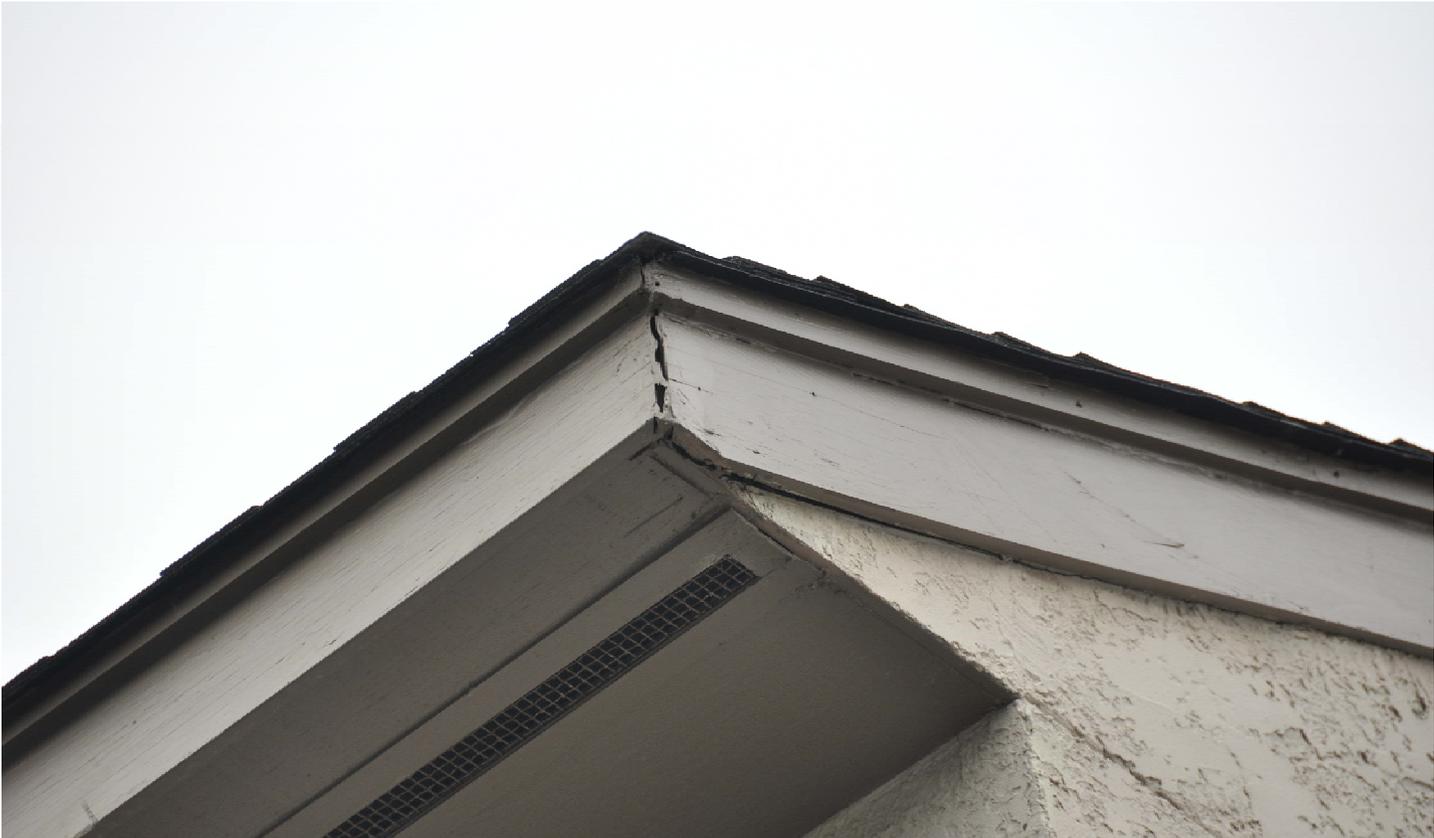
P011. Bluff Villas. Building #5. Corner of fascia trim board

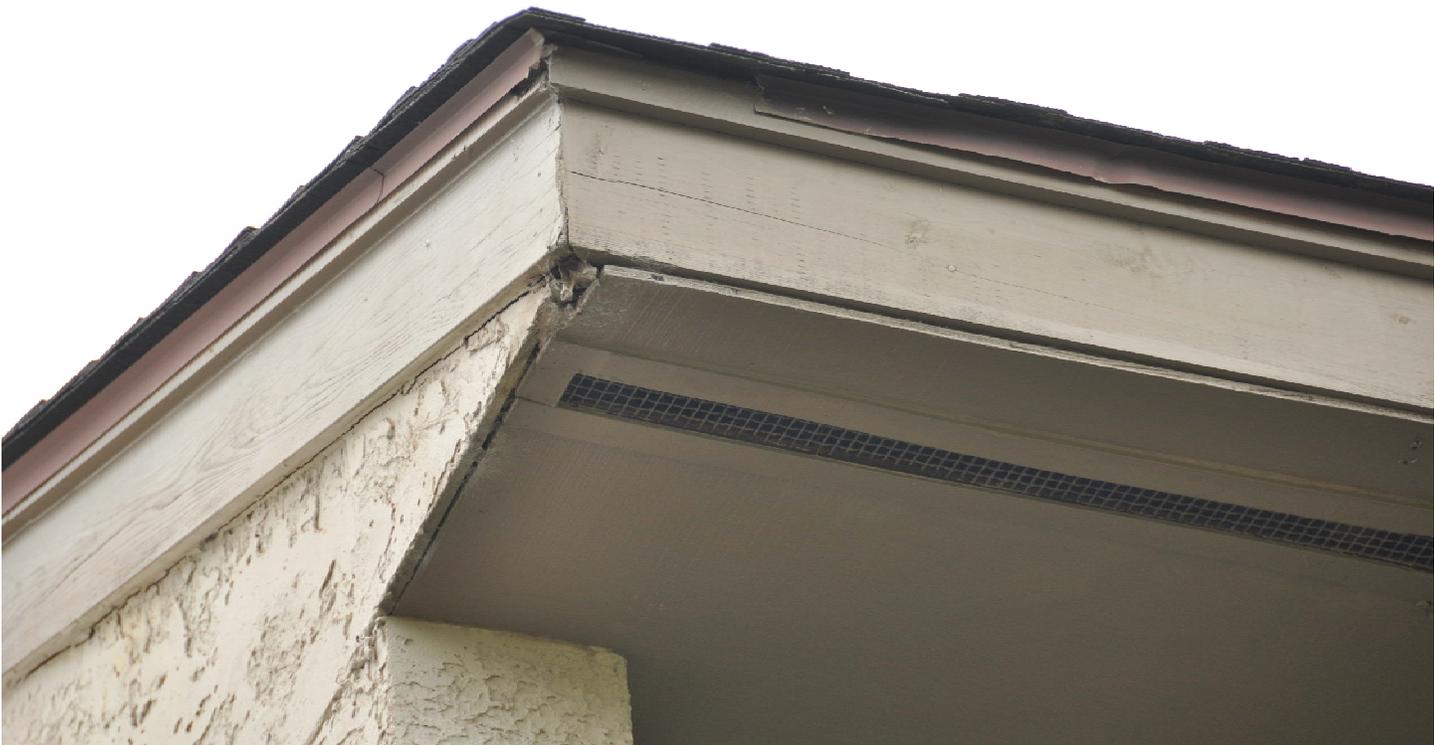
P012. Bluff Villas. Building #5. Corner of fascia trim board

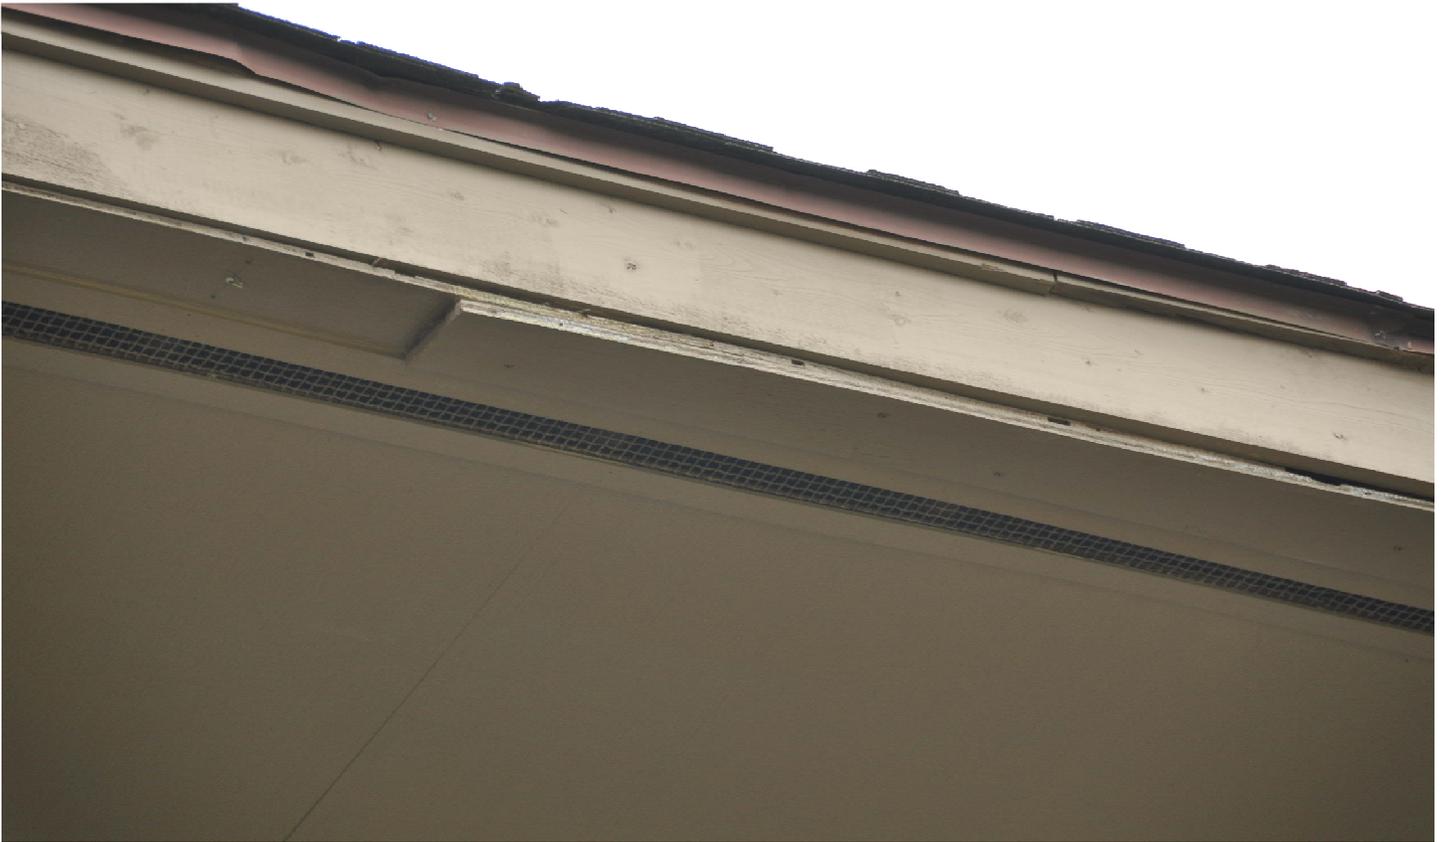
P013. Bluff Villas. Building #3. Rear side fascia trim and soffit panel

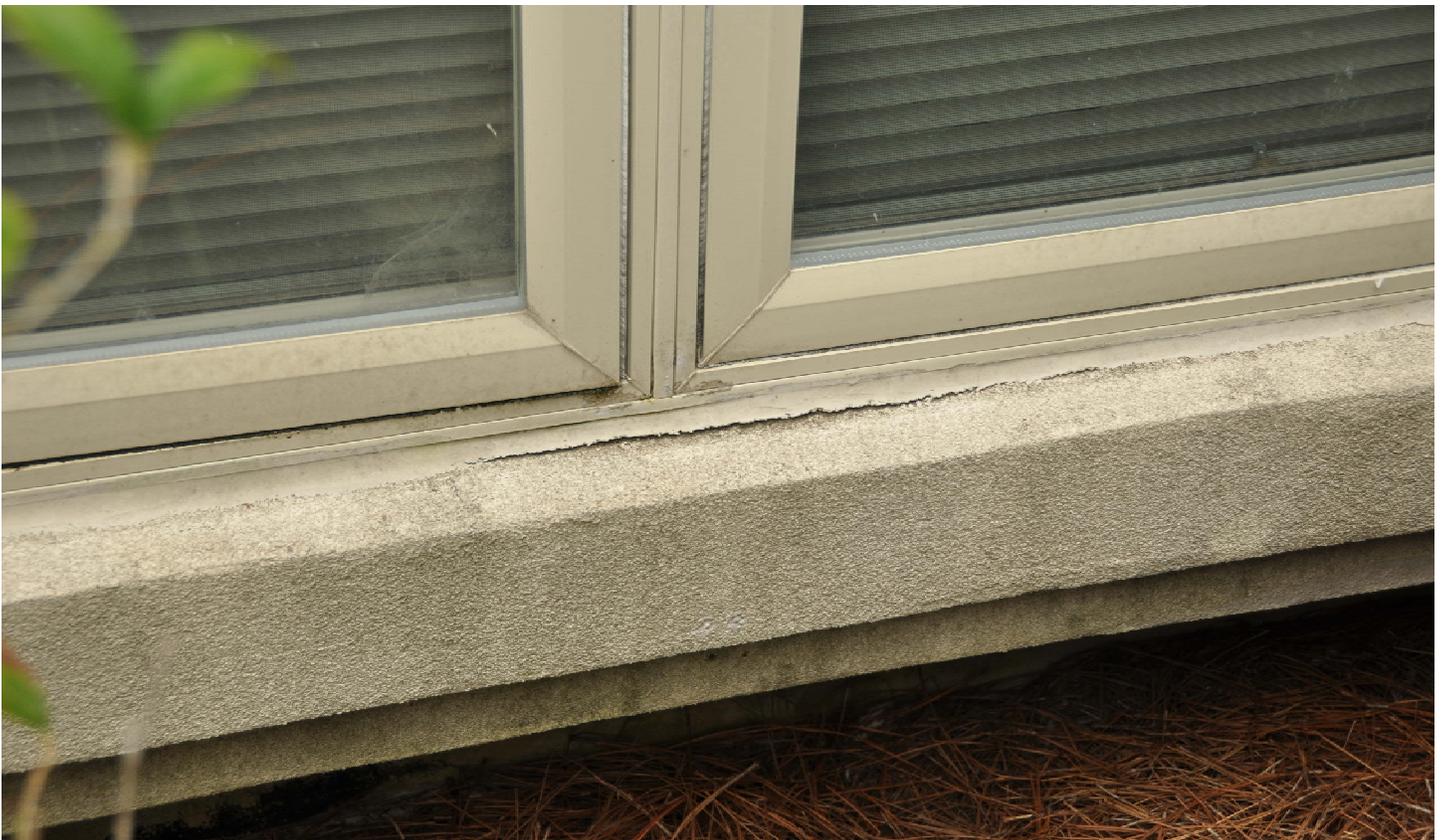
5. Failed window seal application was observed in many areas (Pictures 014, 015, 016). This condition requires immediate attention to prevent moisture penetration to structural framing.

P014. Bluff Villas. Building #3. Front side window.

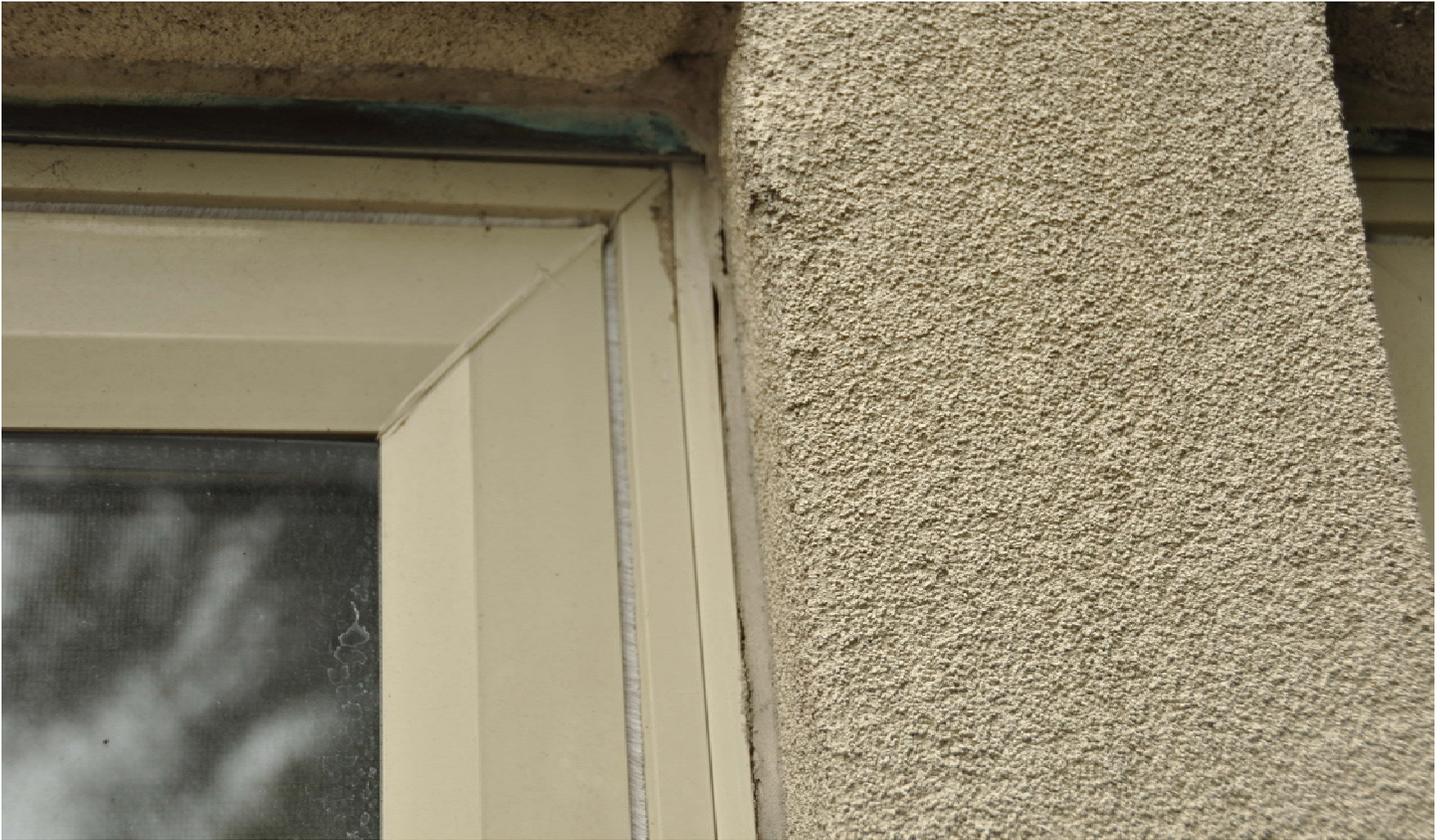
P015. Bluff Villas. Building #3. Front side window.

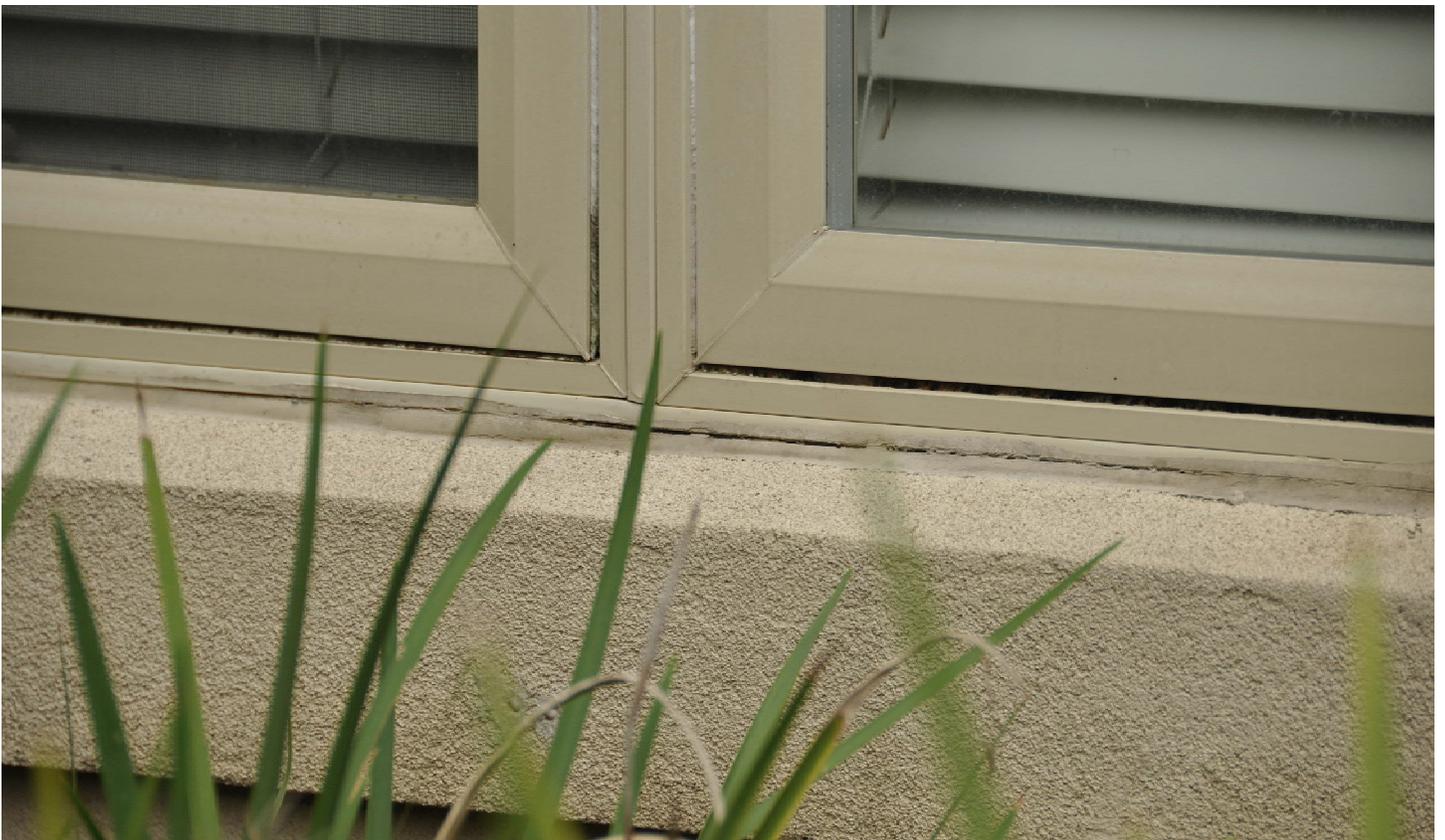
P016. Bluff Villas. Building #2. Front side window.

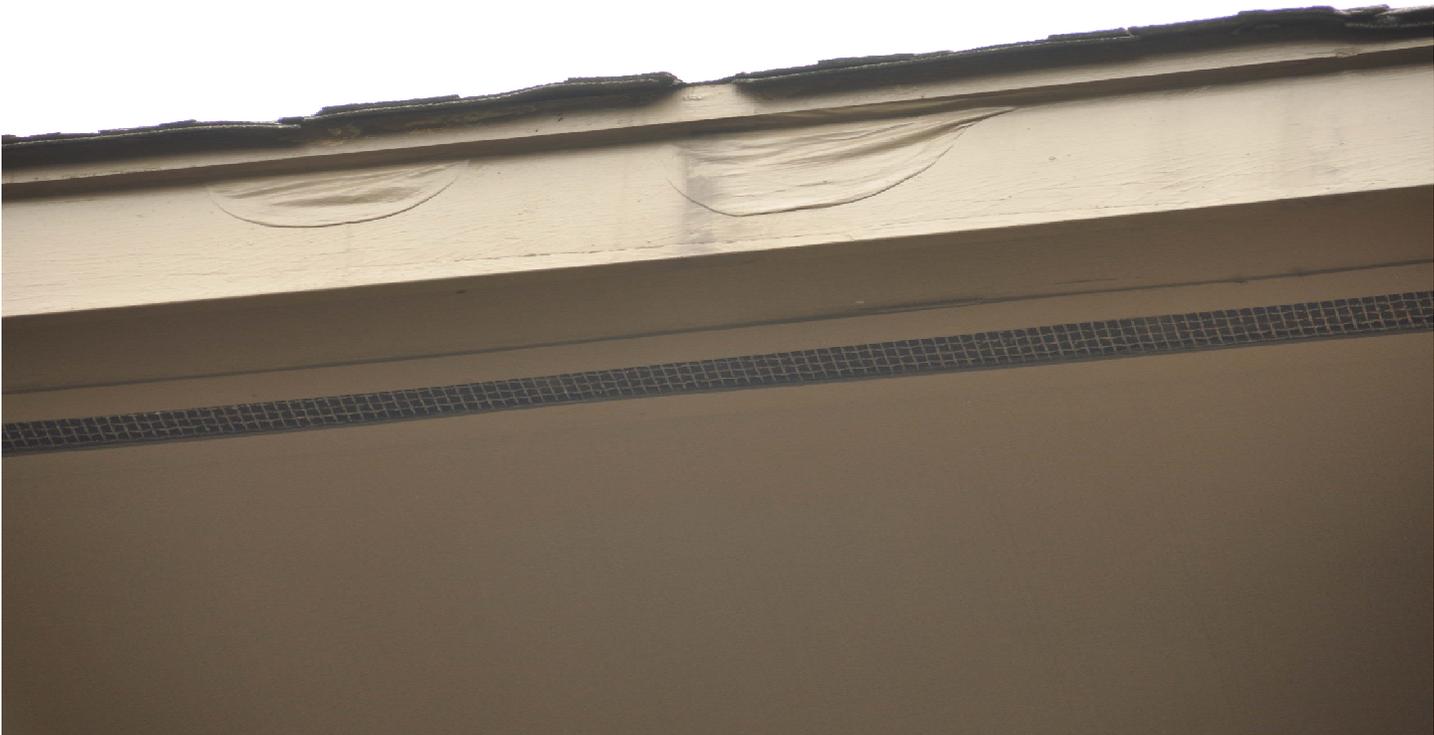
P017. Bluff Villas. Building #2, rear side fascia trim

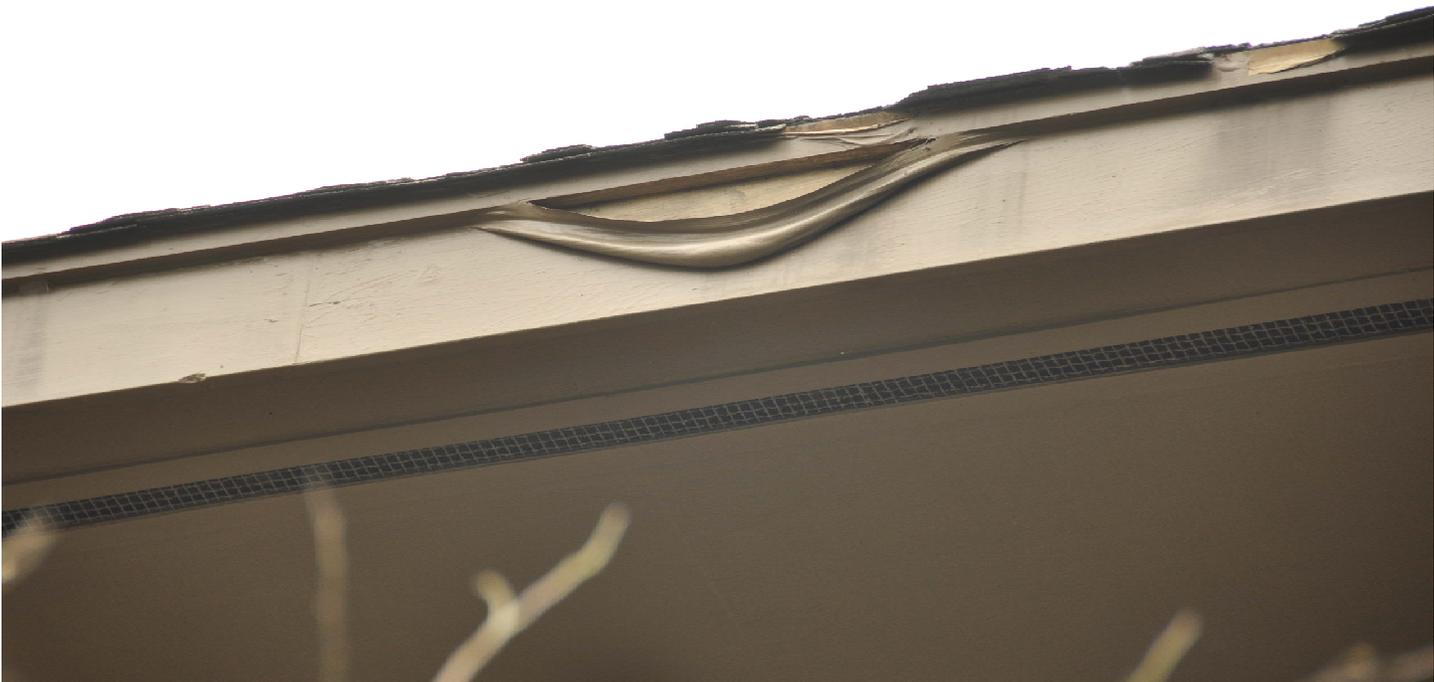
P018. Bluff Villas. Building #2, rear side fascia trim
