EURO CONSTRUCTION, INC.

**Re: Bluff Villas
Sea Pines Plantation
Hilton Head Island, SC 29928**

Pursuant to your request, EURO Construction, Inc. in conjunction with Advance Roofing Services have performed a visual survey of the above referenced property on October 27, 2009. The purpose of the survey was to determine the condition of roof covering on buildings #2, #3 & #5 and to determine overall condition of other exterior elements. A summary of relevant observations made during the survey is provided below.

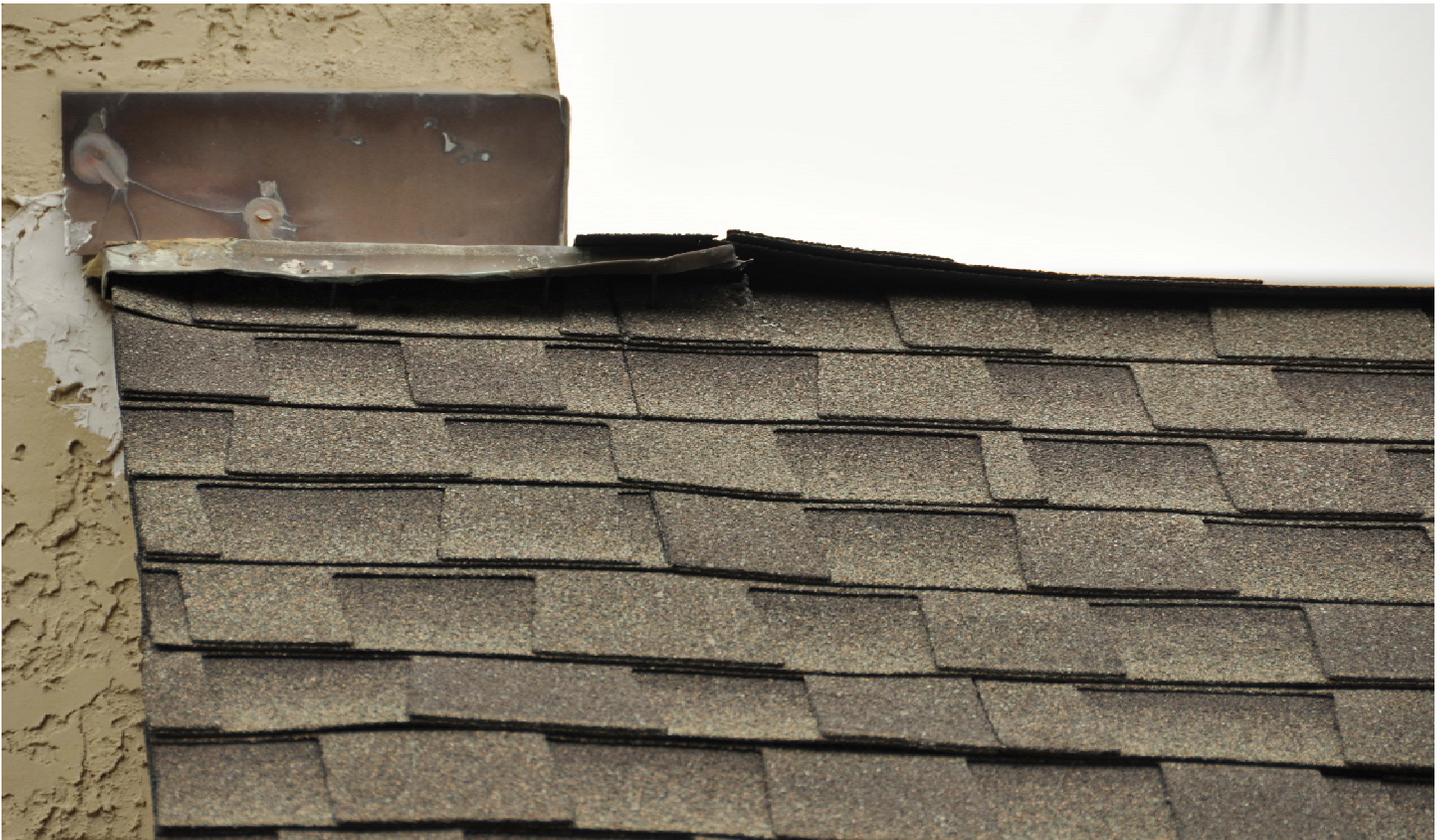
6. At the time of visual survey, we were not able to determine the cause for sagging roof condition in entry roofs (Pictures 007, 008, 009, 019 & 020). Destructive testing would be required in order to determine what is causing these conditions. There is no sealant application behind gutter, though fascia trim boards on the end of entry roofs appears to be in fairly good condition. It is possible, that improper flashing installation at the end of entry roofs, resulting in water penetration behind shingles and wood deterioration in roof plywood and, possibly, rafters. In oerder to determine what’s causing issues with entry roofs, some ceiling boards need to be removed.

P019. Bluff Villas. Building #2. Left side entry roof.

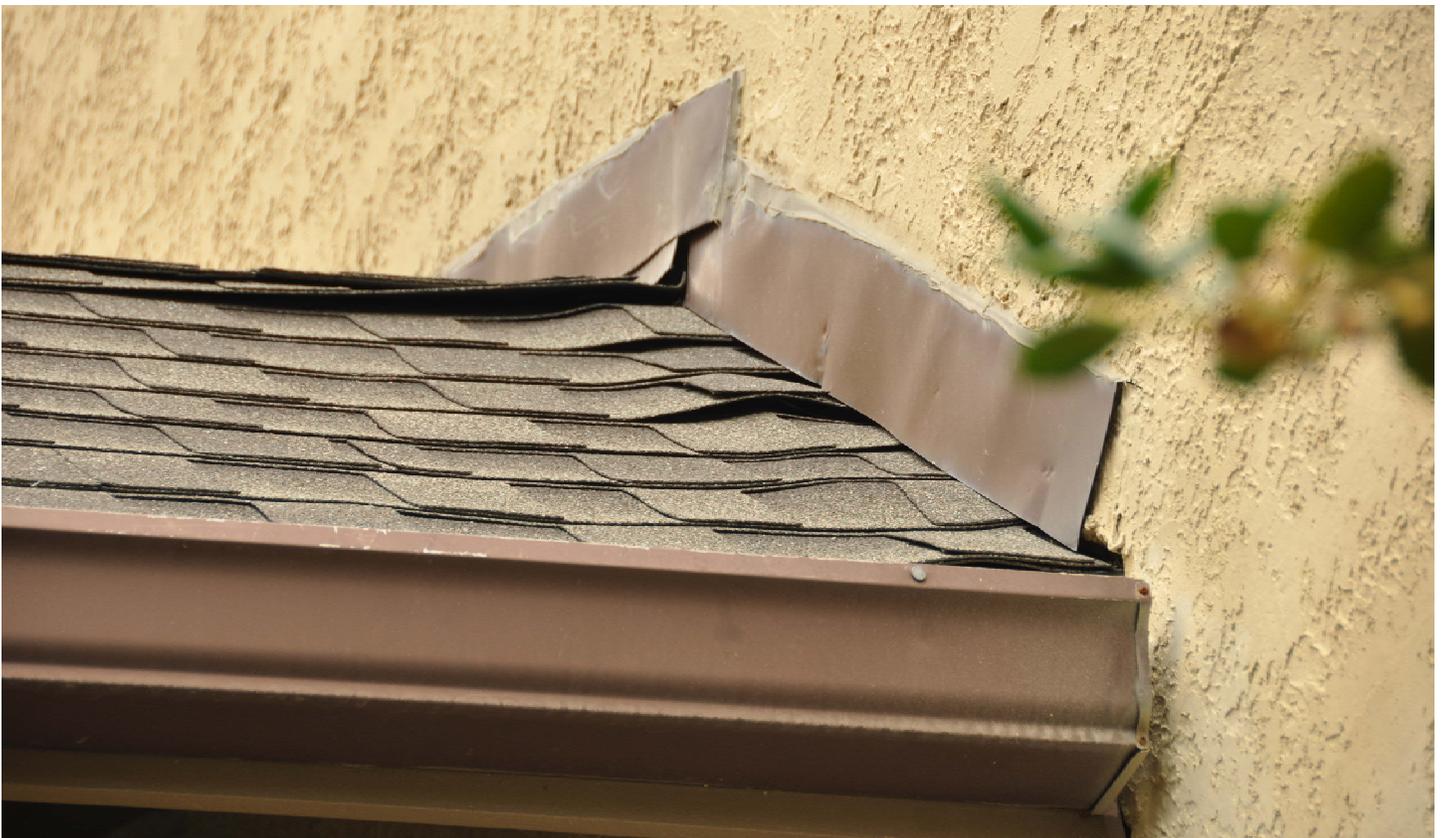
P020. Bluff Villas. Right side entry roof.
