Re: Bluff Villas, Regime 55, Building 8
262 S. Sea Pines Dr., Sea Pines Plantation
Hilton Head Island, SC 29928

Visual inspection of the membrane roof areas on Building 8, performed on December 10, 2009.

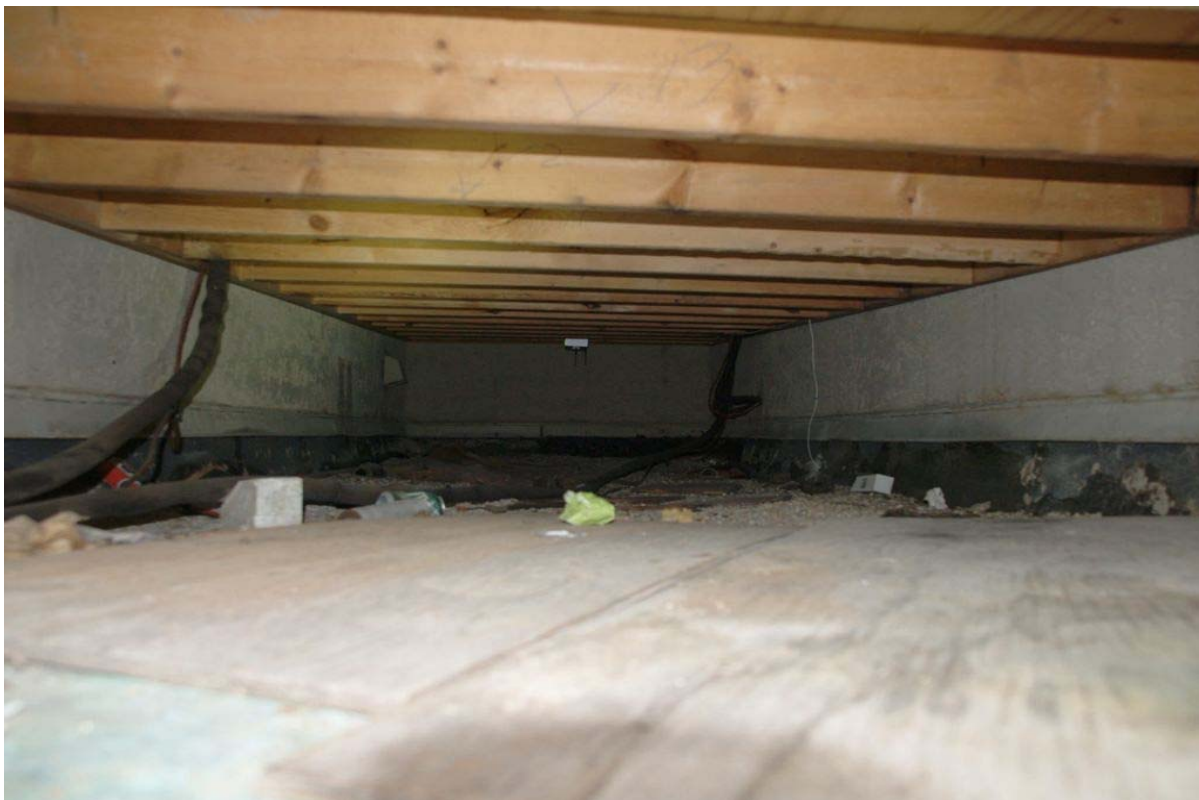
Membrane roof area on the right side: Concrete ceiling over third floor hallway is in good condition. No visual cracks, no water stains. No visual moisture damages or water stains on plywood or joists detected under membrane roof structure below A/C platform.

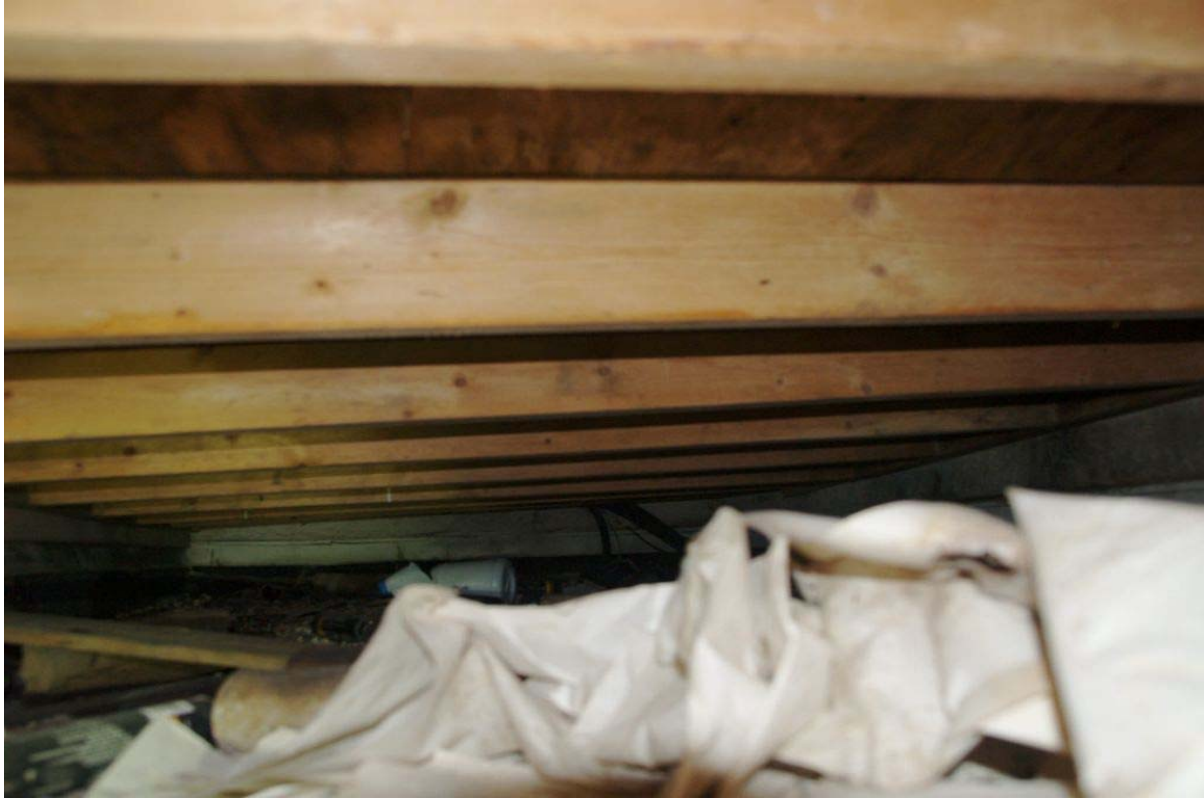
No visual moisture damages or water stains on joists and plywood detected under membrane roof structure across from A/C platform.

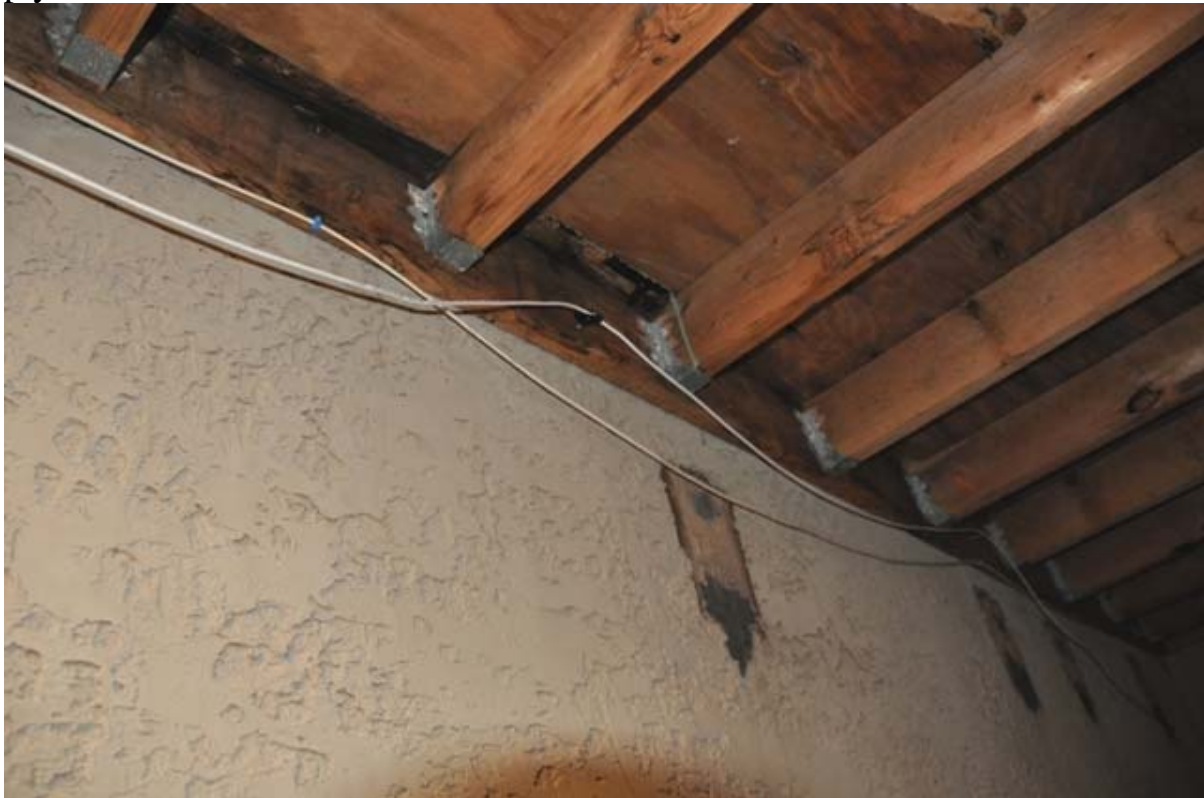
Membrane Roof area on the left side: Wood deterioration evident at the edge of plywood sheets.

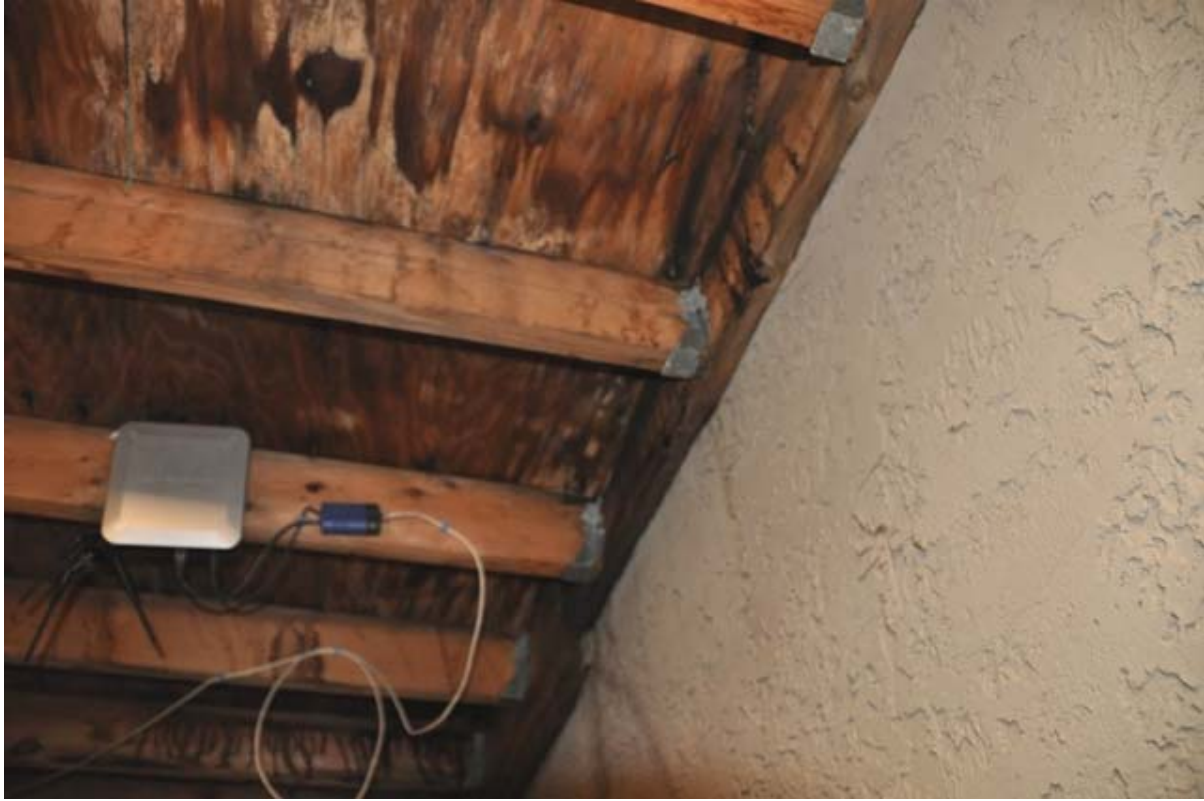
Water stains evident in numerous spots on plywood and joists. Wood deterioration evident on the top of some joists.

Apparently, roof resurfacing was performed without addressing moisture damages to the roof structure.

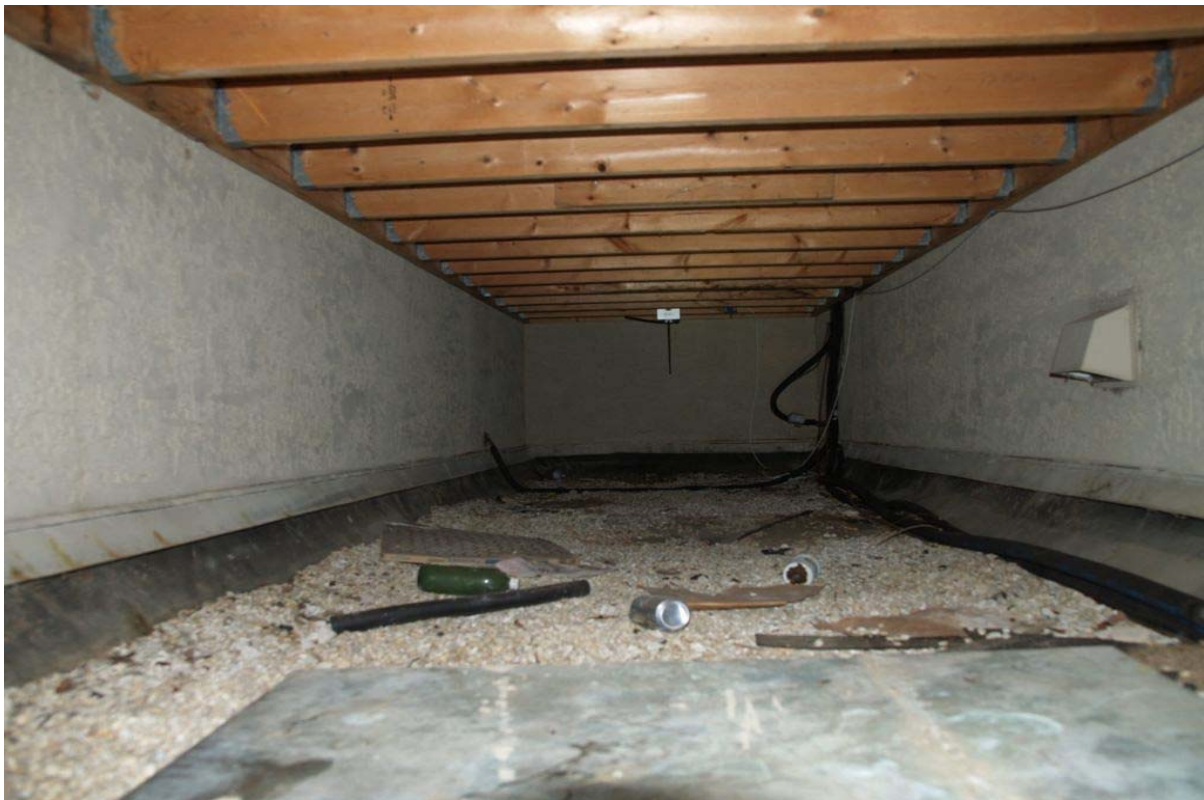
Membrane roof structure below A/C platform. No visual moisture damages nor water stains on plywood and joists detected. Gravel fill is dry.

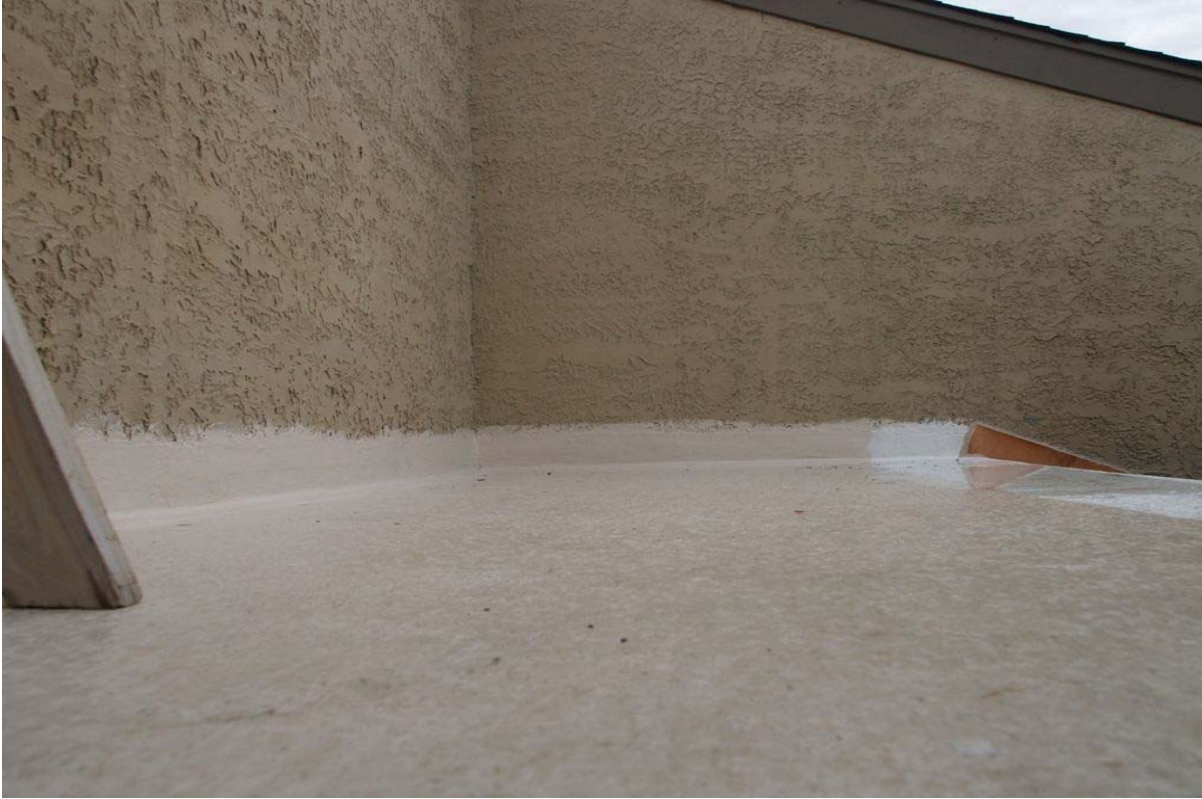
Membrane roof surface across from A/C platform looks like it's been just recently resurfaced.

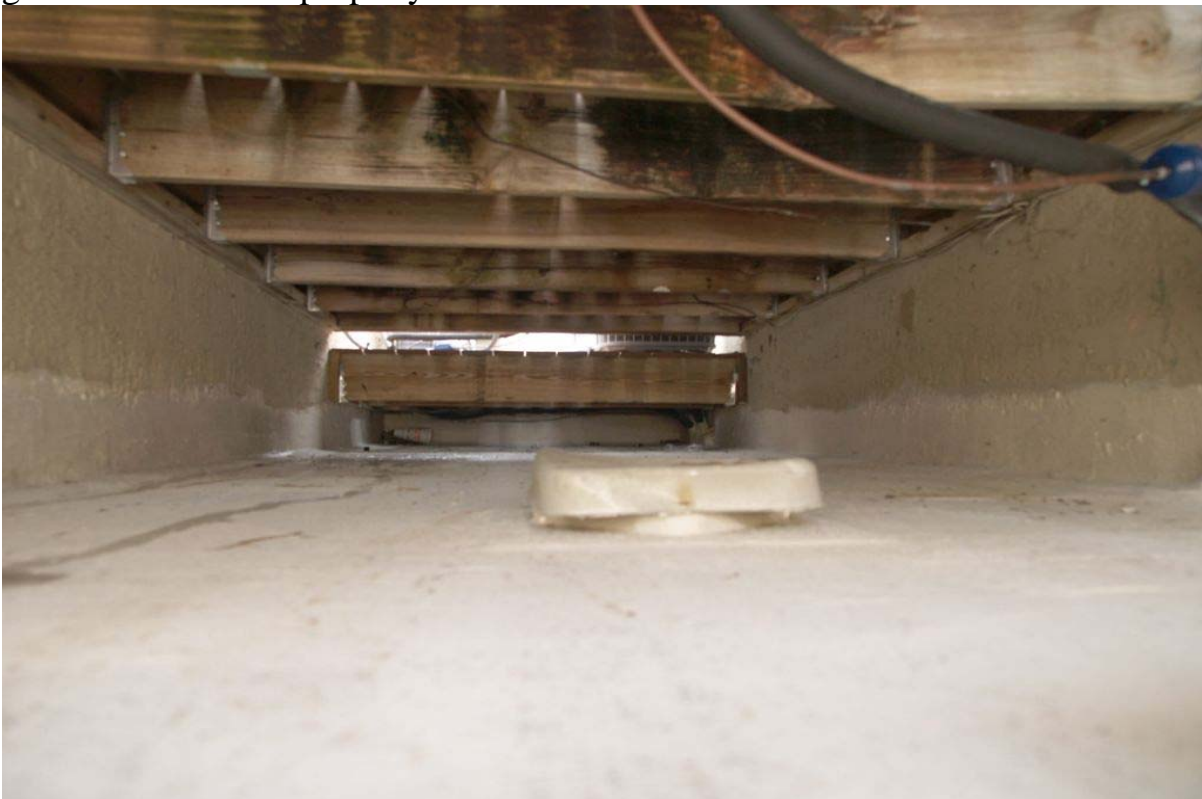
Membrane roof surface below A/C platform also looks fairly new. Ventilation cap in good condition and properly secured.

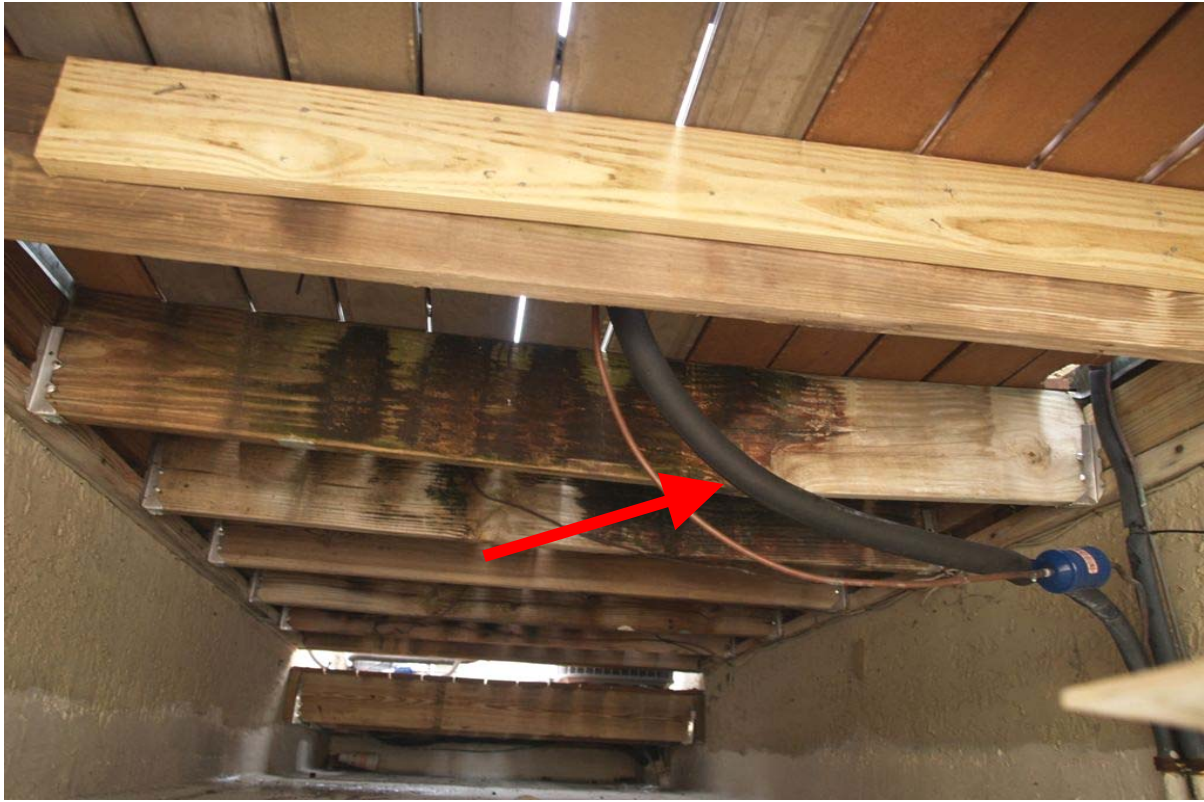
A/C platform joist is broken at the knot behind coolant line.
